THE  
ECCLESIASTICAL  
ARCHITECTURE  
OF SCOTLAND

FROM THE EARLIEST CHRISTIAN TIMES TO THE  
SEVENTEENTH CENTURY

BY  
DAVID MACGIBBON AND THOMAS ROSS  
AUTHORS OF "THE CASTELLATED AND DOMESTIC ARCHITECTURE OF SCOTLAND"

VOLUME ONE

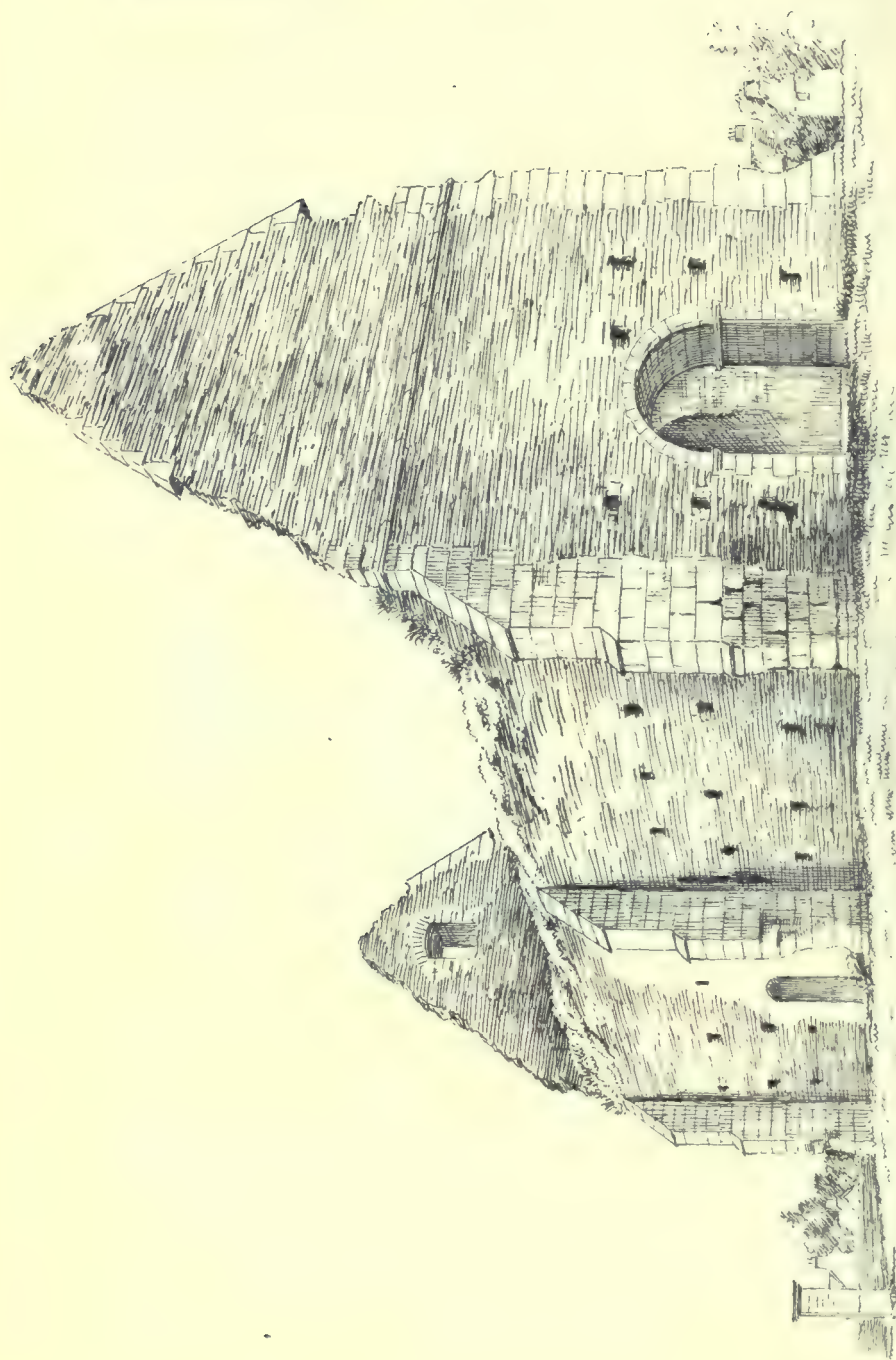
FIG. 327.—St. Martin's, Haddington. View from South-East.

In the east wall there is an opening (Fig. 327) with plain jambs and round arch, which is sometimes called the doorway, but which is clearly the chancel arch. From excavations made a few years ago, it was ascertained that there were foundations of a choir 12 feet square, with a square east wall. The arch is, doubtless, late Norman in design, having a simple moulding on each jamb to form the imposts, and a plain moulding running

round the exterior of the arch stones on the side next the church. The remains of a piscina adjoin the opening on the south side. The round-headed windows in the side walls are tall and narrow, widely splayed towards the interior, and covered with a large round arch on the inside sconson. There have originally been two entrance doors opposite each other in the north and south walls, near the west end. The west wall (Fig. 328) had a single-light window, similar to those in the side walls; but it is now destroyed. The south doorway has been renewed, but some portions of

the jambs of the north doorway still exist in a mutilated state. The sconson arch is segmental.

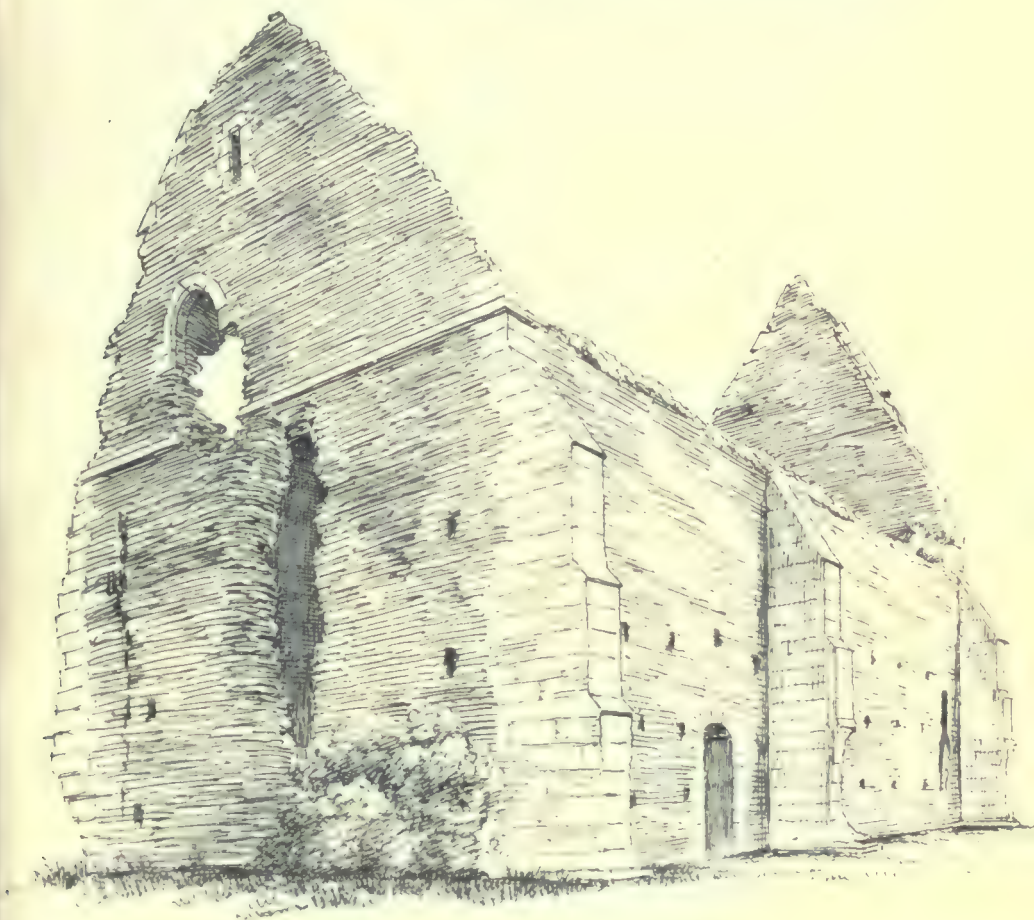
FIG. 328.—St. Martin's, Haddington. View from South-West.

The vault is lofty, and there has evidently been a story above it, as is apparent from the windows in the west gable. The gables are very steep and lofty, and are so constructed in order to admit of rooms in the top

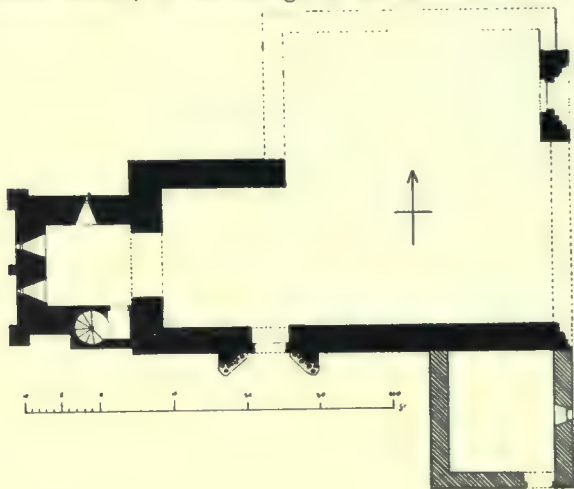
FIG. 329.—Kirkliston Church. Plan.

of the church, so far as can now be ascertained, was an oblong structure (Fig. 329) about 60 feet in length by 26 feet in width externally, but part of the north wall has been removed, so as to allow the church to be extended. The old tower (Fig. 330) stands at the west end of the structure. It is about 21 feet square, and has the solid buttresses projecting on both sides of the angles, which indicate early work

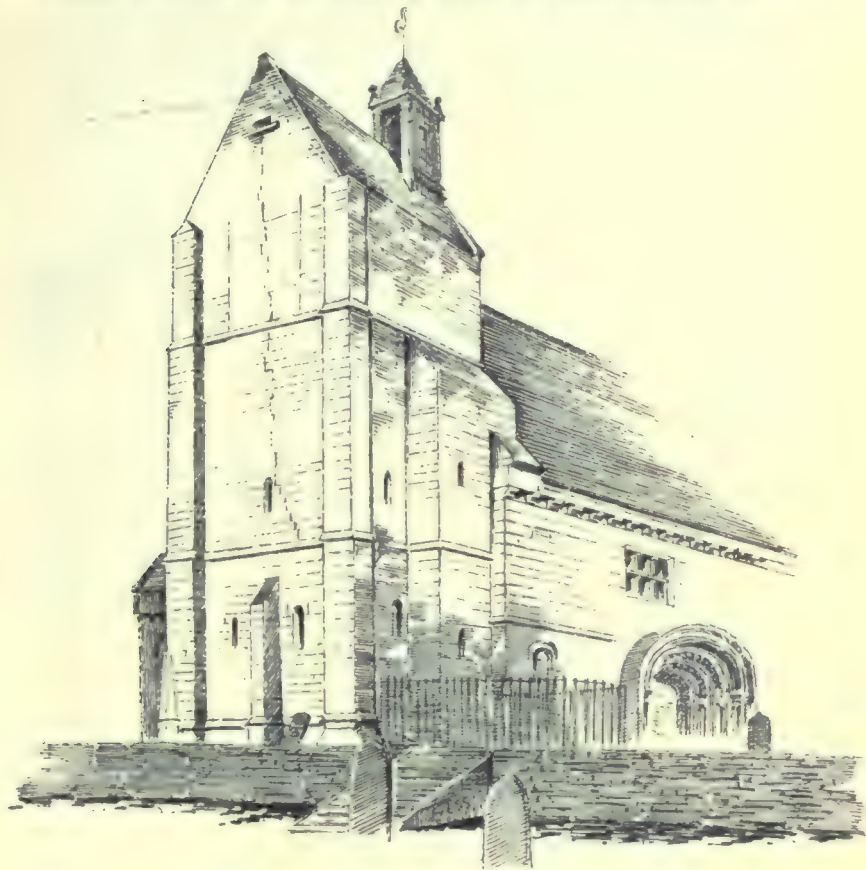
FIG. 330.—Kirkliston Church. View from South-West.

—transition or first pointed. A square projection at the south-east angle of the tower contains a wheel staircase. The windows are mere slits. The roof of the tower is evidently comparatively new. It has a picturesque seventeenth century belfry on the east gable.

The wall of the church in which the above doorway stands is undoubtedly of considerable antiquity, the cornice which carried the original parapet being still *in situ*. (See Fig. 330.)

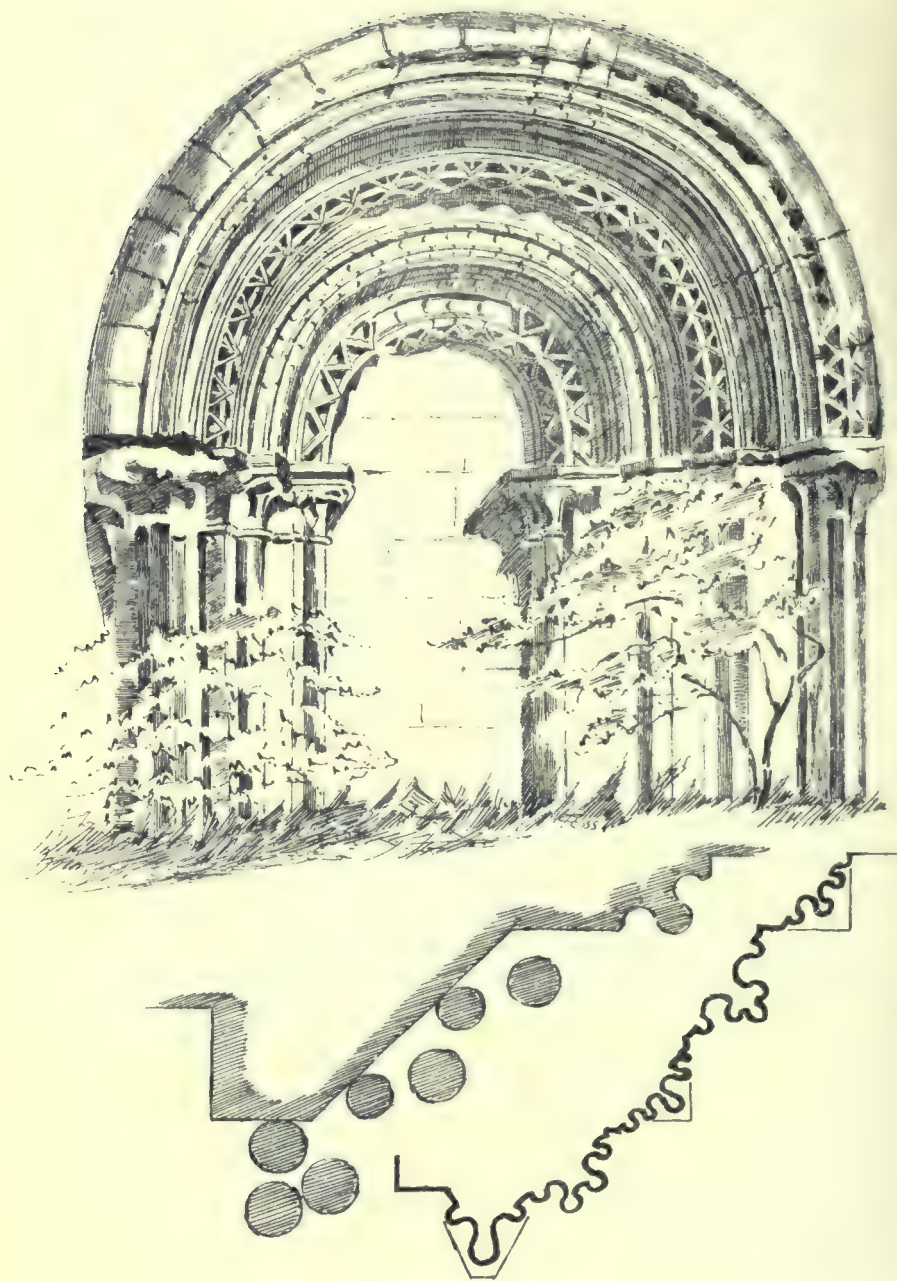
FIG. 331.—Kirkliston Church. South Doorway.

In the south wall of the church there still exists, though partly restored, a splendid Norman doorway. (Fig. 331.) The doorway itself measures 4 feet 9 inches in width, and the whole door-piece measures 14 feet 7 inches over all. Besides the attached rolls on the jambs, which form shafts with caps, there are seven detached shafts on each side, arranged alternately large and small, with three large ones at each outer angle. These had all caps of transition form, but the carving is now almost completely destroyed. The arch, which is semicircular, has numerous mouldings, which are not arranged in the usual square orders, but have

received a freer treatment. The divisions may be regarded as composing four orders, of which the inner order and the third order are enriched with chevron ornaments. The hood moulding has also been carved with the chevron, but the ornament has now almost all disappeared.

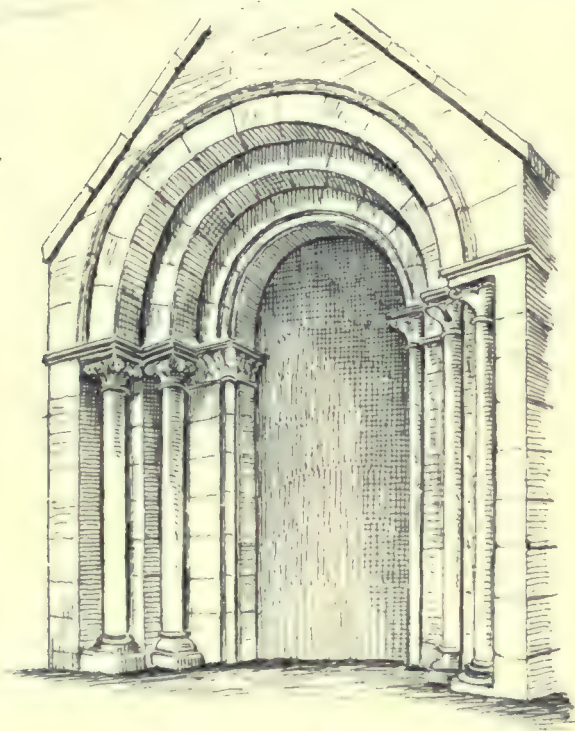
FIG. 332.—Kirkliston Church. North-East Doorway.

way, removed from elsewhere in the building, has been re-erected. (Fig. 332.) The round arch consists of three plain square orders, which spring from the enriched caps of two nook shafts and the jamb moulding. Most of the caps have a transition character, and the carving is fairly preserved.

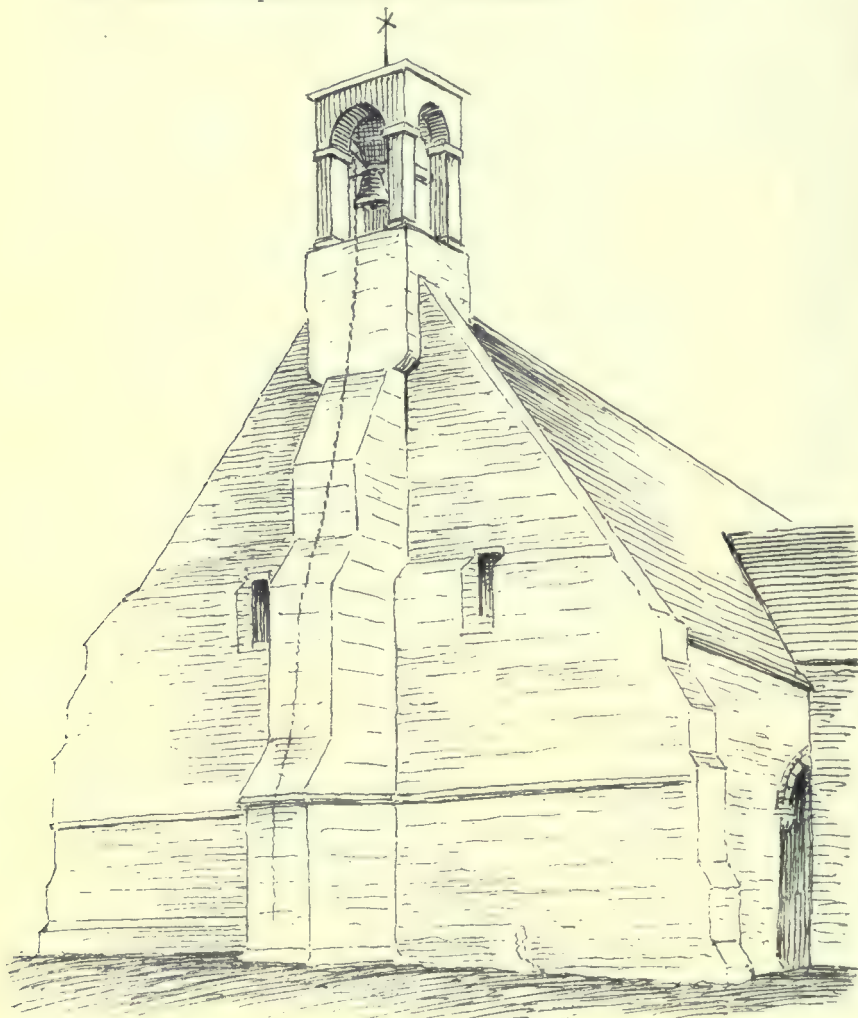
FIG. 333. —St. Mary's, Ratho. View of West End.

The parish church is dedicated to St. Mary, and the "Lady's Well," in the vicinity, is still in use. Although greatly altered and mostly rebuilt, the church still retains some indications of its Norman origin. The view (Fig. 333) shows the west end of the church, crowned with its belfry. The buttresses indicate considerable age, but it is scarcely possible to fix their date. The only Norman relic preserved is the doorway in the south-west wall (seen in the sketch). It is built against by the wall of a wing, so that only a portion of the doorway remains visible. This consists (Fig. 334) of one jamb, which had a nook shaft and a cushion cap, carrying a plain round arch with a hood mould, carved with a zigzag or saw-tooth ornament.

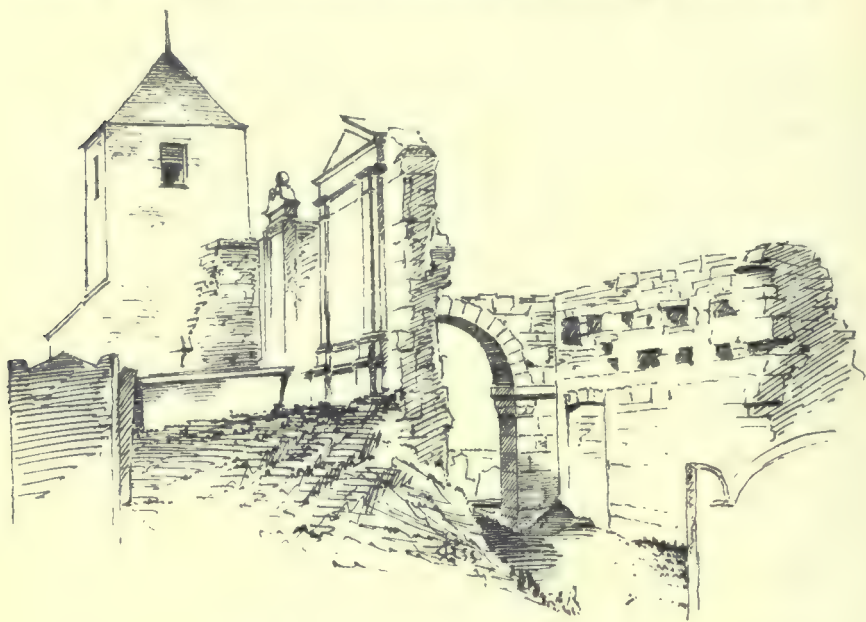
FIG. 335.—St. Peter's, Peterhead. View from South-East.

The remains of the Church of St. Peter, Peterhead (Fig. 335), consist of the side walls of the chancel and the entire chancel arch, with a square tower projecting outwards in the centre of the west wall of the nave. No other portion of the nave remains. The tower and west wall are late, but the chancel is of the Norman period. The arch is quite plain, and is supported on square jambs having Norman cushion caps.

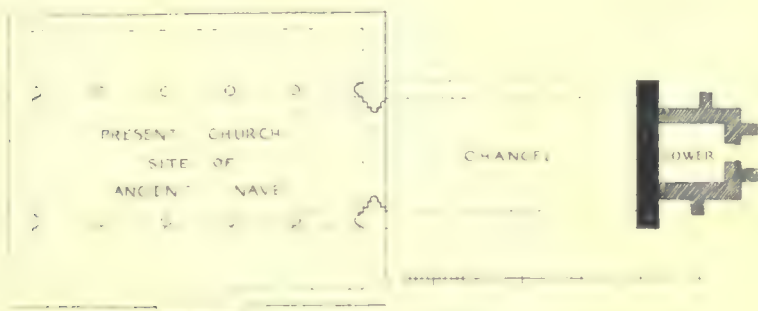
FIG. 336.—St. Mary's, Rutherglen. Plan.

In Ure's *History of Rutherglen* it is stated that there was a nave with side aisles, 62 feet long by 25 feet wide, "exclusive of the additions on the back and front;" that is, exclusive of the side aisles. Assuming these to have been eight or ten feet wide, we should have a church nearly corresponding in size with the present erection, built about a century ago, and occupying the site of the nave, as shown in outline on the plan, on which are also indicated the nave piers. The nave was thus about 62 feet long by 45 feet wide, and the chancel was about 42 feet long by 20 feet wide inside. Ure, by a mistake easily made, gives the dimensions of the chancel as ten feet less in length. He also mentions that there were five pillars on each side of the nave. This may mean four whole pillars and two halves (the responds), as shown in the plan, which, however, merely pretends to approximate to something like what the original was.

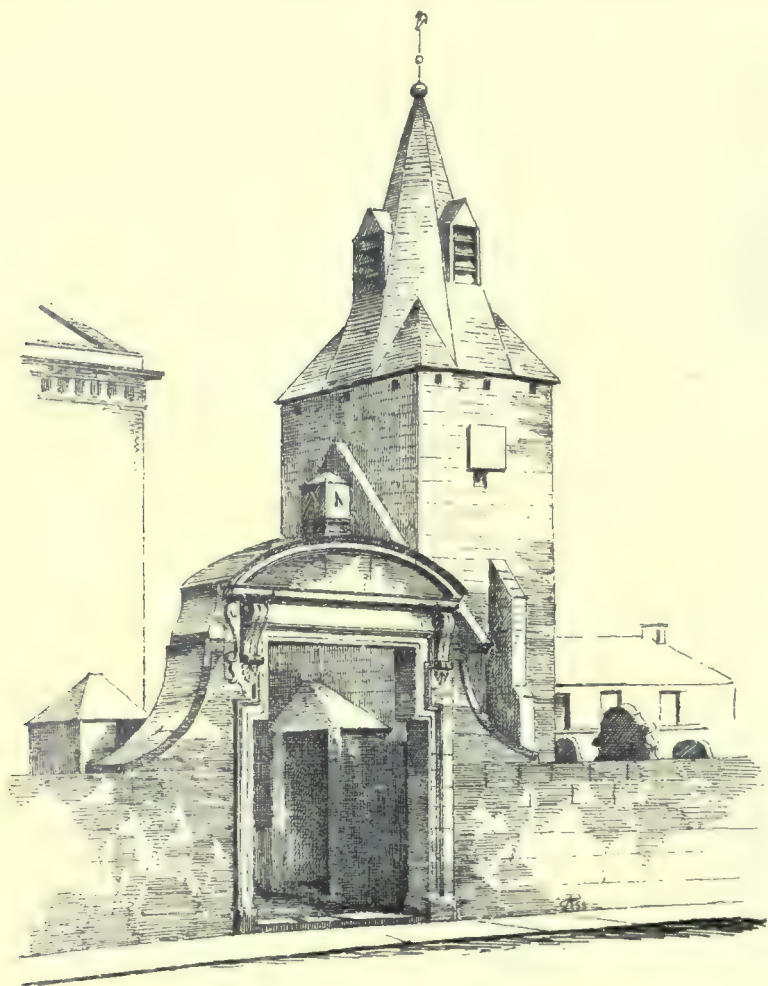
FIG. 337.—St. Mary's, Rutherglen. Tower, &c.

Only the merest fragment of this ancient church now remains, consisting of the east wall (Fig. 336), with an eastern tower attached to it. The masonry of the east wall shows it to be of the Norman period. There has been no opening of any kind in this wall. The returns of the chancel walls are only indicated on the east wall by the slightest traces in the jointing, so completely have they been cut away. The eastern tower (Fig. 337) is quite a unique feature in Scotland. It had no connection with the church, although built against it, and is of later erection by probably two or three centuries. The doorway is low and lintelled, and has a simple splay. The upper part of the tower has apparently been rebuilt, and, with the slated roof, dates doubtless from the seventeenth century.

The tower is about 10 feet 6 inches square inside, and about 34 feet high to the top of the masonry. It contains no stair.

The church stands near the west end of the cemetery, on the north side of the main street. The entrance from the street is through a picturesque lych-gate of Renaissance design, dated 1663. (See Fig. 337.) It is surmounted by a sundial, dated 1679.

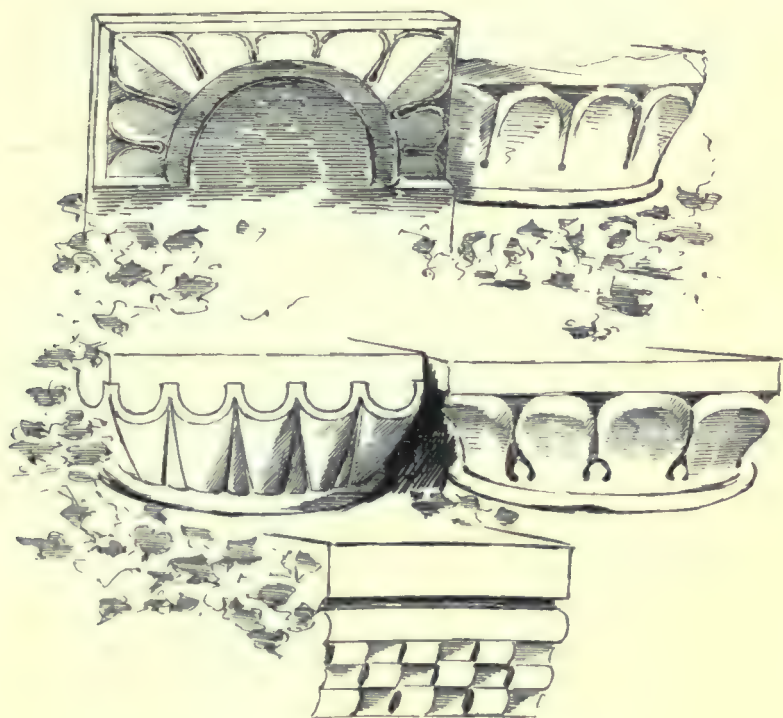
FIG. 338.—St. Mary's, Rutherglen. Norman Caps.

Ure gives a drawing of the interior of the church, with detailed sketches of some of the capitals of the piers. Four of these capitals are preserved in a garden rockery in Rutherglen, and the annexed sketch (Fig. 338) shows them as they are seen lying there half covered up and concealed. The upper one, which shows the bed of the capital, is a respond from one of the end walls, and the diameter of the column, as indicated by the inner circle, is 18 inches, the breadth across the abacus being 2 feet 5 inches. The enrichments of these capitals correspond with those indicated by Ure in his view, and he informs us that the pillars, of which there were five on each side, "are smooth and round, except the middle ones, which are octagonal." He further says that the arcade "arches are pointed, but the point is hardly discernible," and with this the view in his book agrees. Above the arcade he shows a small square window, probably measuring about 2 feet each way, and widely splayed

remaining fragments. The lower member, shown in Fig. 338, is a carved stone, probably part of the chancel arch. It is enriched with the alternate billet ornaments so frequent in such arches during the Norman period.

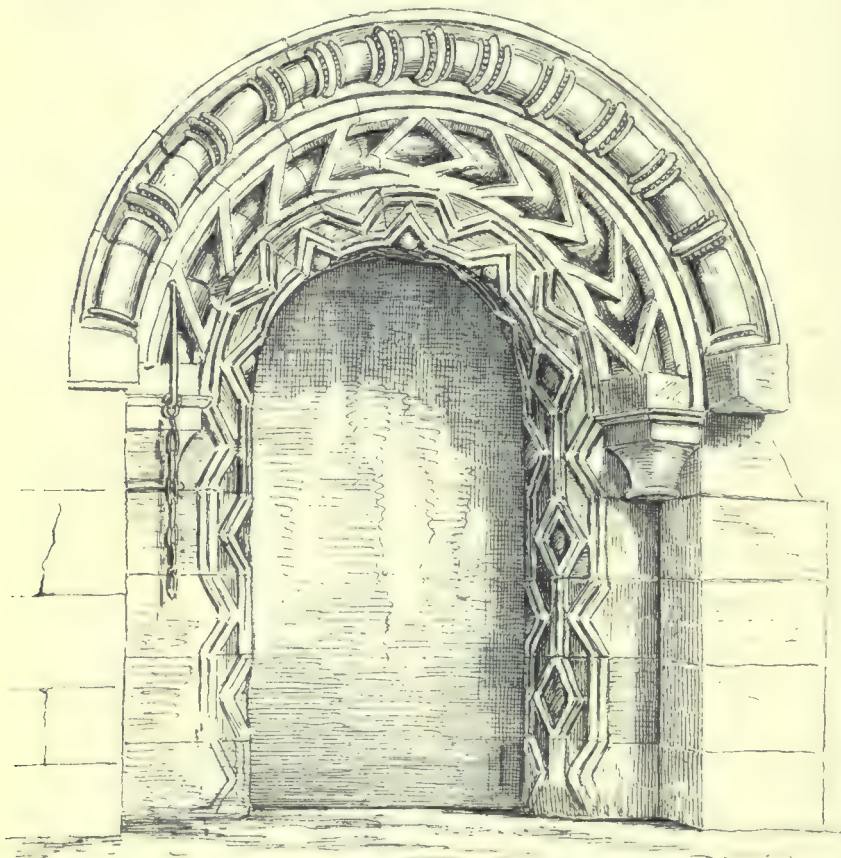
FIG. 339.—Lamington Church. North Doorway.

The church and village were founded by one Lambin, in the twelfth century. The doorway (Fig. 339) is in the north wall of the church. It

is an elaborate example to find in this remote and quiet pastoral district. The arch mouldings and ornaments are well preserved, but, unfortunately, the shafts are wanting. The caps are quite plain. There are three orders of mouldings, all enriched with characteristic Norman ornaments. It will be observed that in that of the outer order the spaces between the rings gradually diminish from the caps to the crown of the arch.

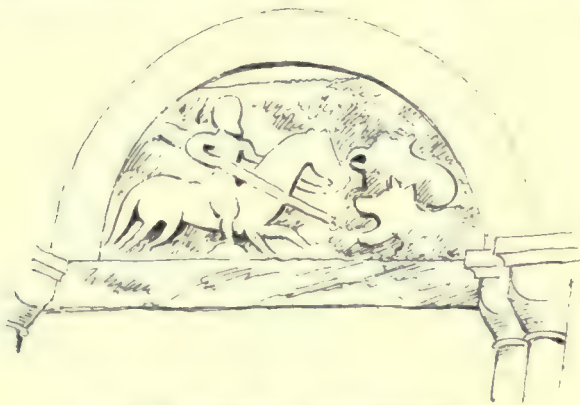
FIG. 342.—Linton Church. Tympanum in Porch.

the tympanum of the doorway of the ancient church (Fig. 342), in which the knight is represented on horseback thrusting his spear into the mouth of the monster. It seems more likely, however, that the sculpture has rather an ecclesiastical connection, and may possibly represent St. George

and the Dragon, being an allegorical representation of religion, or faith overcoming evil. Possibly, the existence of the sculpture may have given rise to the traditional account of it. In 1858, this sculpture was removed from the old doorway and inserted over the entrance to a new

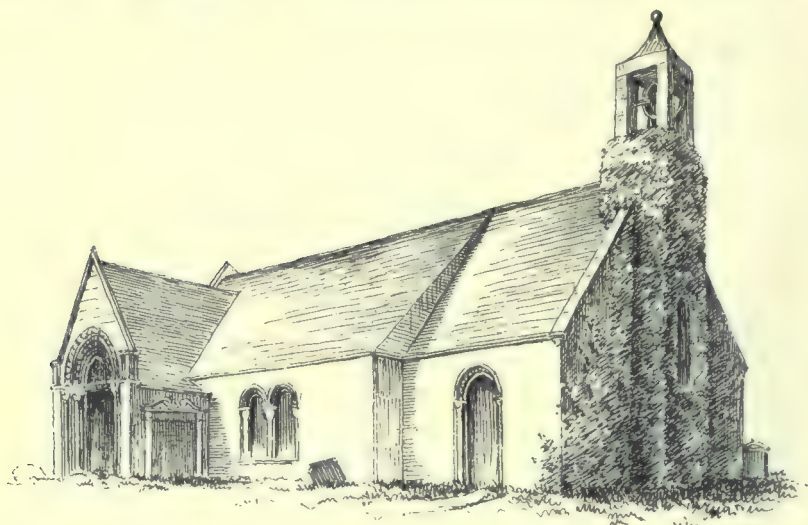
FIG. 343.—Linton Church. View from South-East.

porch, then erected. The porch is seen in the sketch of the church. (Fig. 343.) This sculptured tympanum is remarkable as one of the few examples of sculpture in a similar position in Scotland.

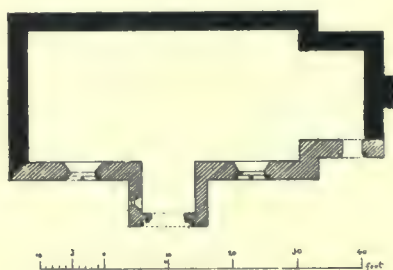
FIG. 344.—Linton Church. Plan.

The walls of the church are old, but it has been almost entirely restored and renewed. (Fig. 344.)

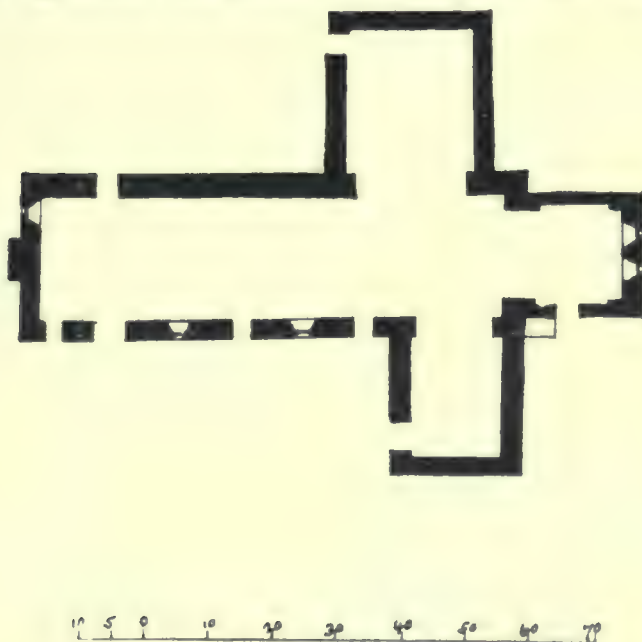
FIG. 345.—Duns Church. Plan.

From a photograph in Mr. Ferguson's possession, of what remains of the walls of the chancel the masonry looks very like Norman work. If one might judge from the plan (Fig. 345), it evidently consisted of a long nave and a chancel, with a north and south aisle or wing not opposite each other, and probably built at later periods, such as are common in connection with Scottish churches. The nave was about 72 feet long by about 19 feet wide. The chancel was almost a square of about 17 feet, thus corresponding with the Norman chancels of Ledgerwood and Duddingston.

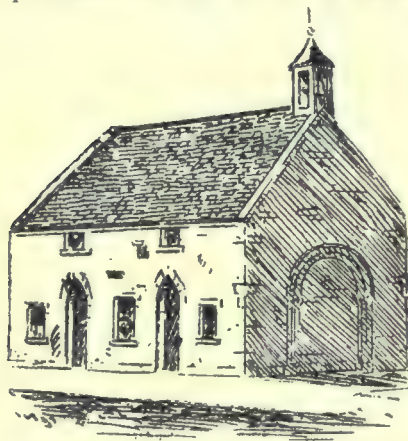
FIG. 346.—Lundie Church in 1786.

The apse appears to have been taken down, in 1786, during some alterations, and the chancel arch, indicated in the sketch (Fig. 346), was built up. A tomb house was erected on the site of the apse, where it still remains. The building was

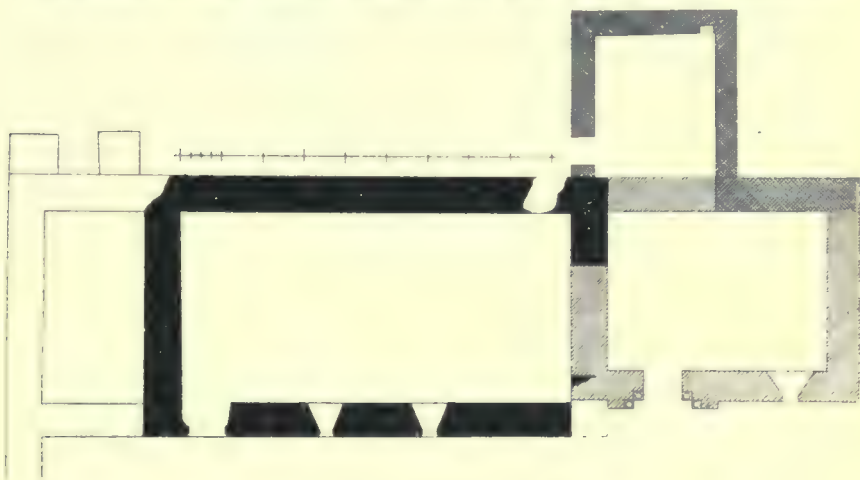
FIG. 348.—Kirkmaiden Church. Plan.

It consists (Fig. 348) of a nave, 37 feet 6 inches long by 18 feet wide internally, and the walls are 4 feet in thickness. They are little reduced from their original height, and the west gable is also little diminished.

There are only three openings in the walls—viz., a doorway and two windows, all in the south wall. These were, till recently, greatly destroyed, but they have been restored by Mr. Galloway,\* who has no doubt, judging from what remained, that they were all originally round-headed, and has rebuilt them accordingly.

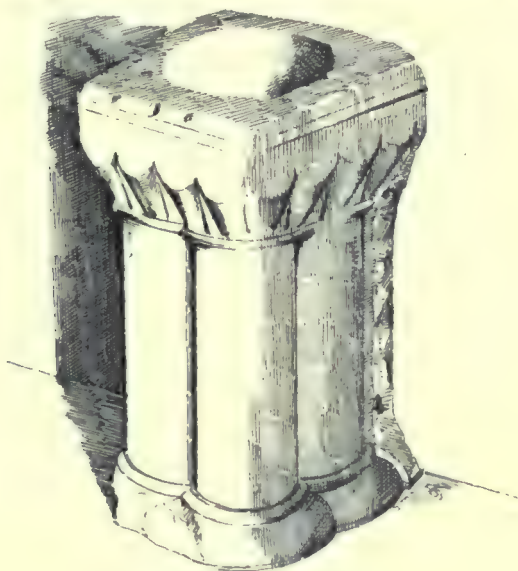
FIG. 349. —Herdmanston Font.

The font is of yellow freestone, in one piece, and although somewhat worn and battered in part, is still in a good state of preservation. The base is partly damaged, and the surface of the top is somewhat broken away towards the front (Fig. 349), so that it measures a little higher at the back than at the front.

basin is in the form of a Norman cushion capital, with four rounds on each face, the abacus having a splayed projection of about a quarter of an inch. The font has evidently been meant to be placed against a wall, as all its parts—base, shaft, and capital—abut against a square haffit perfectly plain on the back, to admit of its standing in such a position. The ends of this haffit are very much broken.

The dimensions of the font are—base, 7 inches high ; shaft, 17 inches ; capital, 11 inches ; total height, 2 feet 11 inches. Width across shafts,  $13\frac{1}{4}$  inches ; capital,  $16\frac{3}{4}$  inches across front, and from back to front,

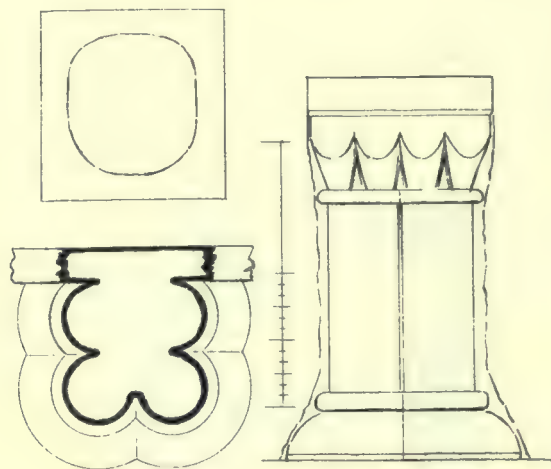
FIG. 350.—Herdmanston Font. Details.

As will be seen from the Plan (Fig. 350), the central part consists of four rounded shafts, having a boldly pronounced base moulding. The

including haffit,  $17\frac{1}{4}$  inches. The basin, which is rounded (see Plan), is  $11\frac{3}{4}$  inches wide by 5 inches in depth. It is flat in the bottom and has no perforation.

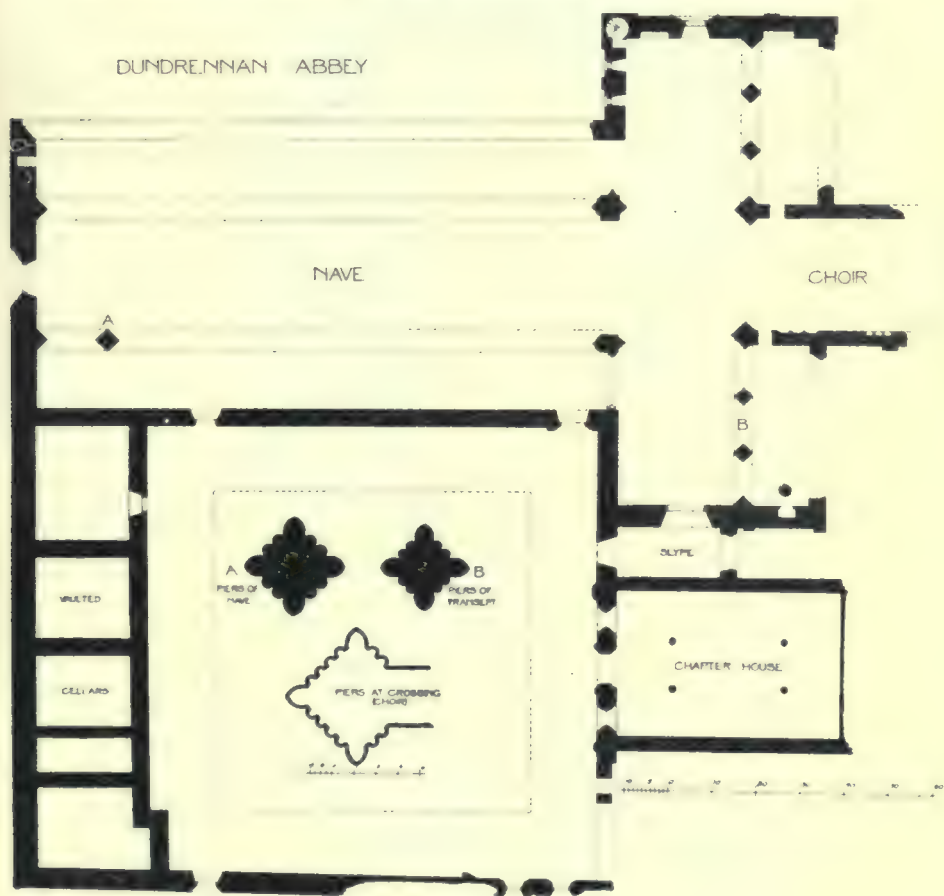
FIG. 351.—Dundrennan Abbey. Plan.

The nave of the church (see Fig. 351) was 134 feet long within the

walls, and comprised eight bays. The central division was 31 feet wide,

and each aisle 16 feet wide, giving a total width of 63 feet internally.

is some doubt whether this is not a restoration. It will be observed that the section of the piers of the nave and transept, and also the piers of the crossing (see Fig. 351), bear a close resemblance to those of Sweetheart Abbey. But the forms here are earlier, the fillet on the outer angle being absent at Dundrennan, though present at Sweetheart.

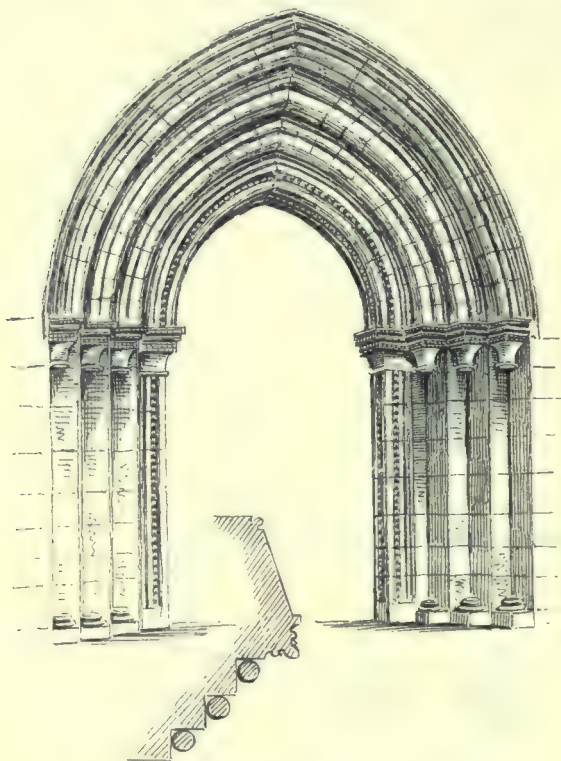
FIG. 352.—Dundrennan Abbey. Western Doorway.

Of this part of the church only portions of the west end and south wall remain. The west wall contains the original western doorway, which is of simple Transition design. The doorway had three nook shafts besides the jambs, and the arches are in four orders of plain mouldings (Fig. 352). The caps, which have square abaci, are peculiar from the large quantity of very small nail head ornaments with which they are decorated (Fig. 353). The inner mouldings were renewed by the Government in 1842. The west wall retains the responds of the main piers of the nave, and a portion of one of the piers, being the westmost of the south arcade of the nave, also exists, both showing a

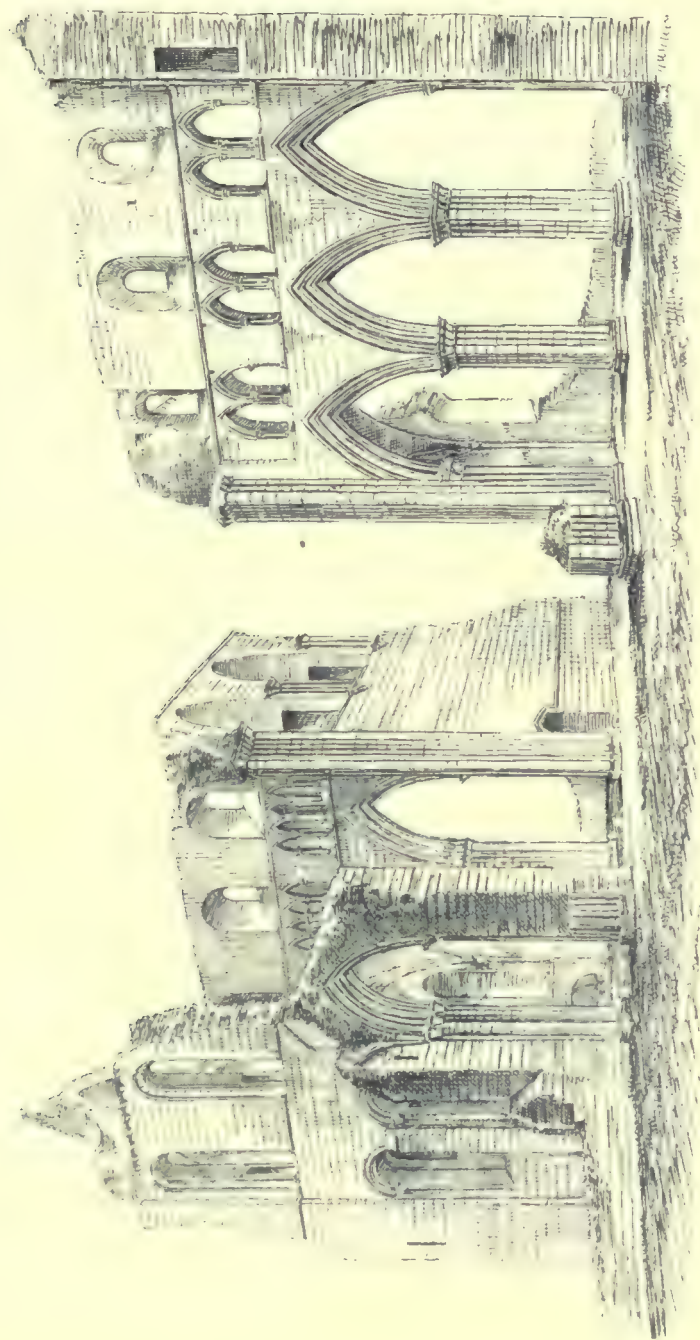
FIG. 354.—Dundrennan Abbey. From South-West.

The pointed work is evidently of an early character (see Fig. 354). The squat round-headed windows of the clerestory, with their broad internal splay occurring above the pointed windows of the triforium, indicate a period of Transition. The use of the square abacus is also general throughout the work. The very acute form of the main arches of the transepts has probably arisen from the three bays having to be fitted into the space between the old north and south end walls, and at the same time requiring to be carried up as high as the main arches of the

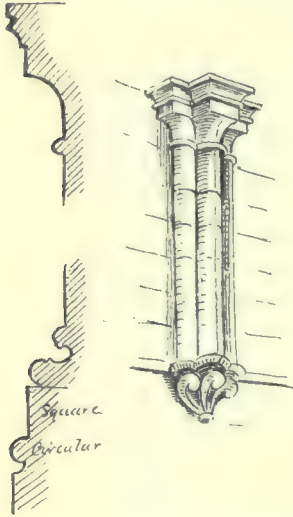
FIG. 355.—Dundrennan Abbey. Wall Shafts in Clerestory of Choir.

walls are found very characteristic examples of late Norman work. The large plain round openings of the clerestory and the triple shafts with Norman caps and corbels (Fig. 355) are unmistakable features. The choir and transept were apparently at first completed in this style late in the twelfth century, and sometime in the thirteenth century it has been desired to build the nave on a larger scale. It has then been also resolved to rebuild the interior of the transept, including the piers at the crossing, in the same style as the nave, so as to bring the transept as far as possible into harmony with the new design.

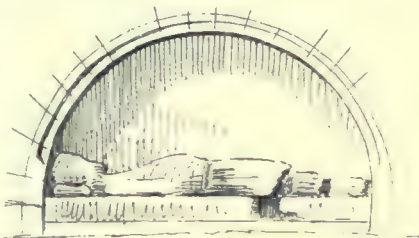
FIG. 357.—Dundrennan Abbey. Monument in North Transept.

In the north wall of the aisle of the north transept, and in a round arched recess (Fig. 357), lies the sculptured effigy of a knight wearing a suit of chain armour, and with legs crossed. This is said to be the

statue of Alan, Lord of Galloway, who was interred in the abbey in 1234. There seems also to have been a fine monument in the choir, and numerous portions of cusped and carved work are to be seen piled up in the nave, which may be fragments of this or some other ruined structure of the same nature.

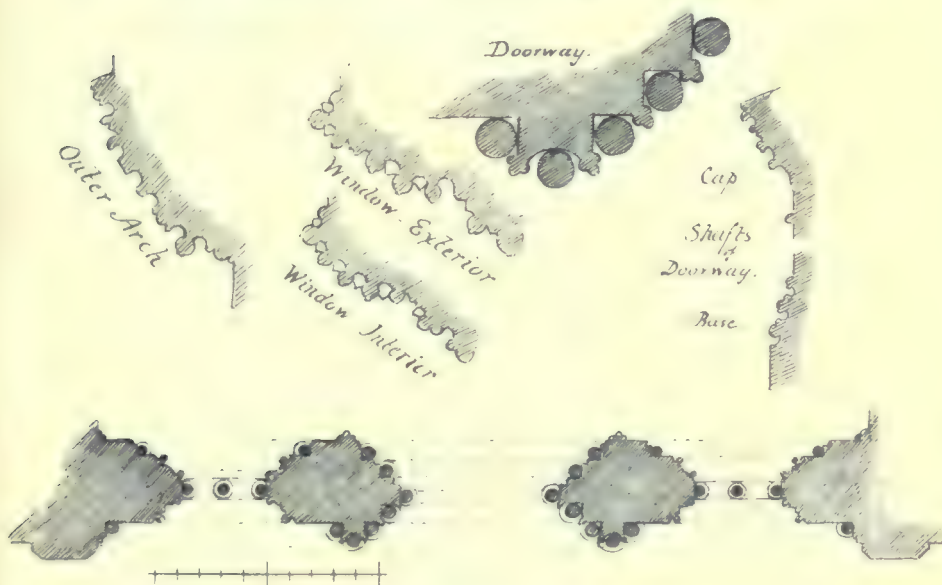
FIG. 358.—Dundrennan Abbey. Plan and Details of West Wall of Chapter House.

side, adjoining the south transept, is the slype from which a wide door (doubtless modernised) leads into the transept. To the south of the slype stood the chapter house, which must have been a very beautiful building, measuring 51 feet from east to west by 34 feet from north to south internally. From some fragments of shafts which remain, and from the responds against the west wall, it appears to have been vaulted in three spans from north to south, with four bays from east to west, but the vaults have now entirely disappeared. The front wall next the cloisters, however, fortunately survives (Fig. 358).

The features are all beautifully designed, and the details are of the purest and most elegant forms (see Fig. 358), the whole being enriched with finely carved dog-tooth and other ornaments.

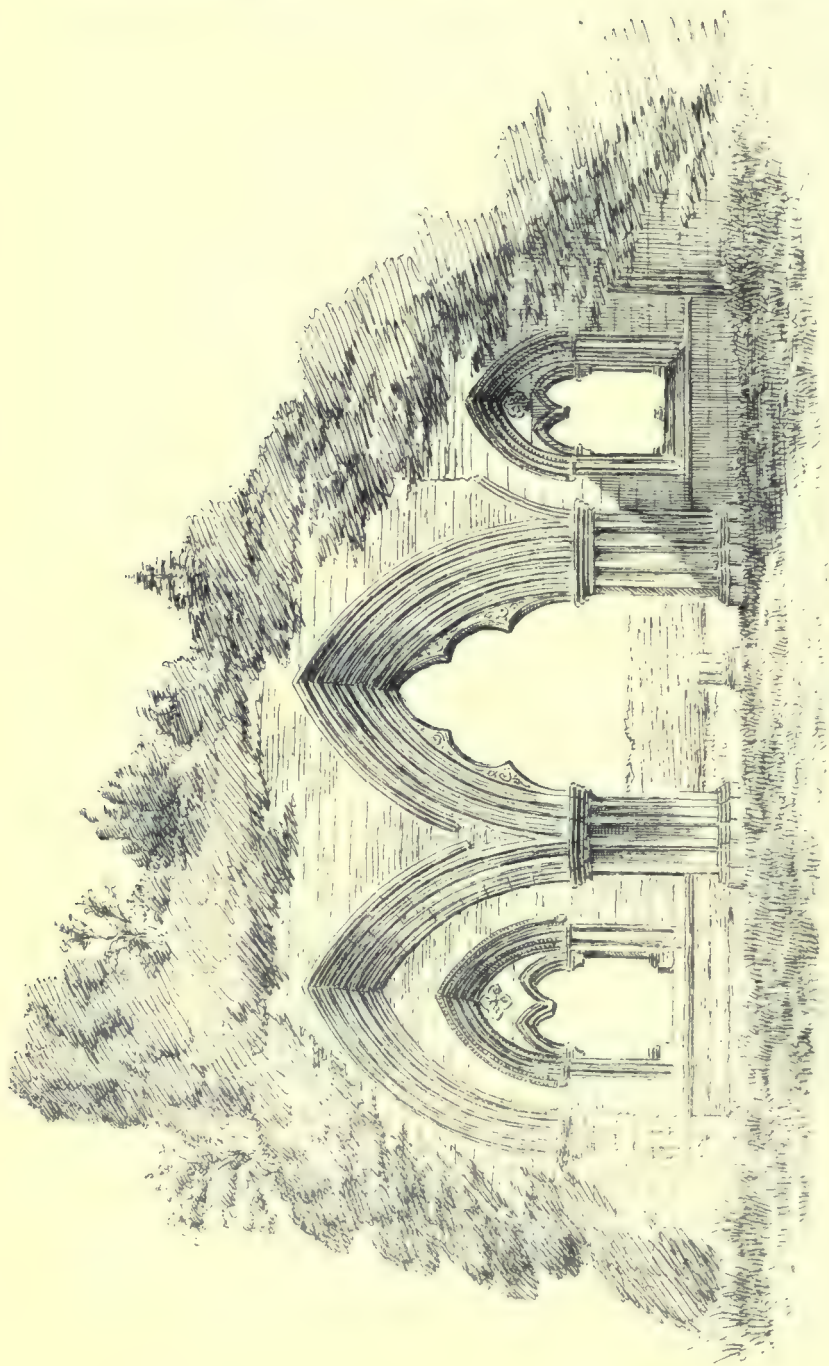
FIG. 539.—Dundrennan Abbey. Exterior of West Wall of Chapter House.

It is a splendid specimen of first pointed architecture (Fig. 359). In the centre is the doorway, and on each side a window, divided into two openings by a central shaft. The doorway and windows were, as usual, designed to remain open, so that the brethren in the cloisters might hear all that passed in the chapter house.

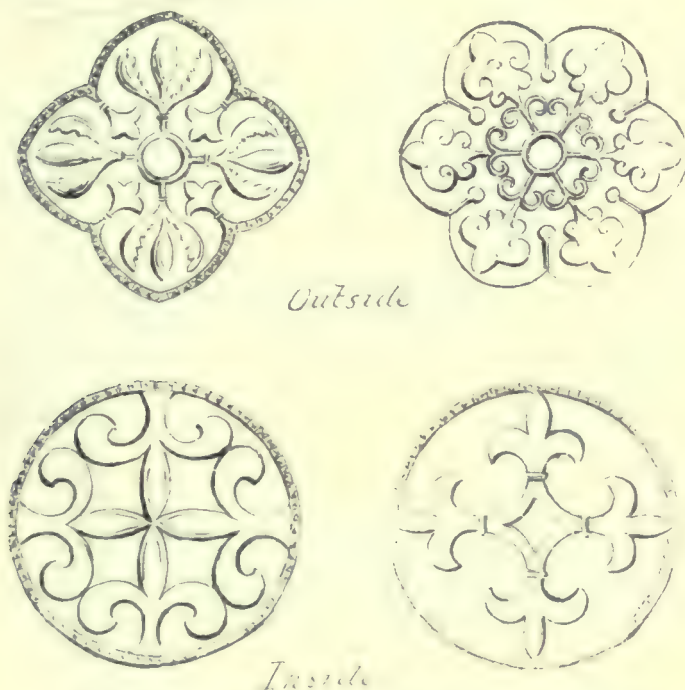
FIG. 360.—Dundrennan Abbey. Ornaments over Windows of Chapter House.

In the arch mouldings a very profuse employment of the fillet is noticeable. The panels in the tympanum over the double arch of the windows, both in the exterior and interior, are filled in with plain, but finely designed, geometric figures (Fig. 360), and the simple bold cusps of the doorway have been carved with foliaceous scroll work, now almost obliterated by decay.

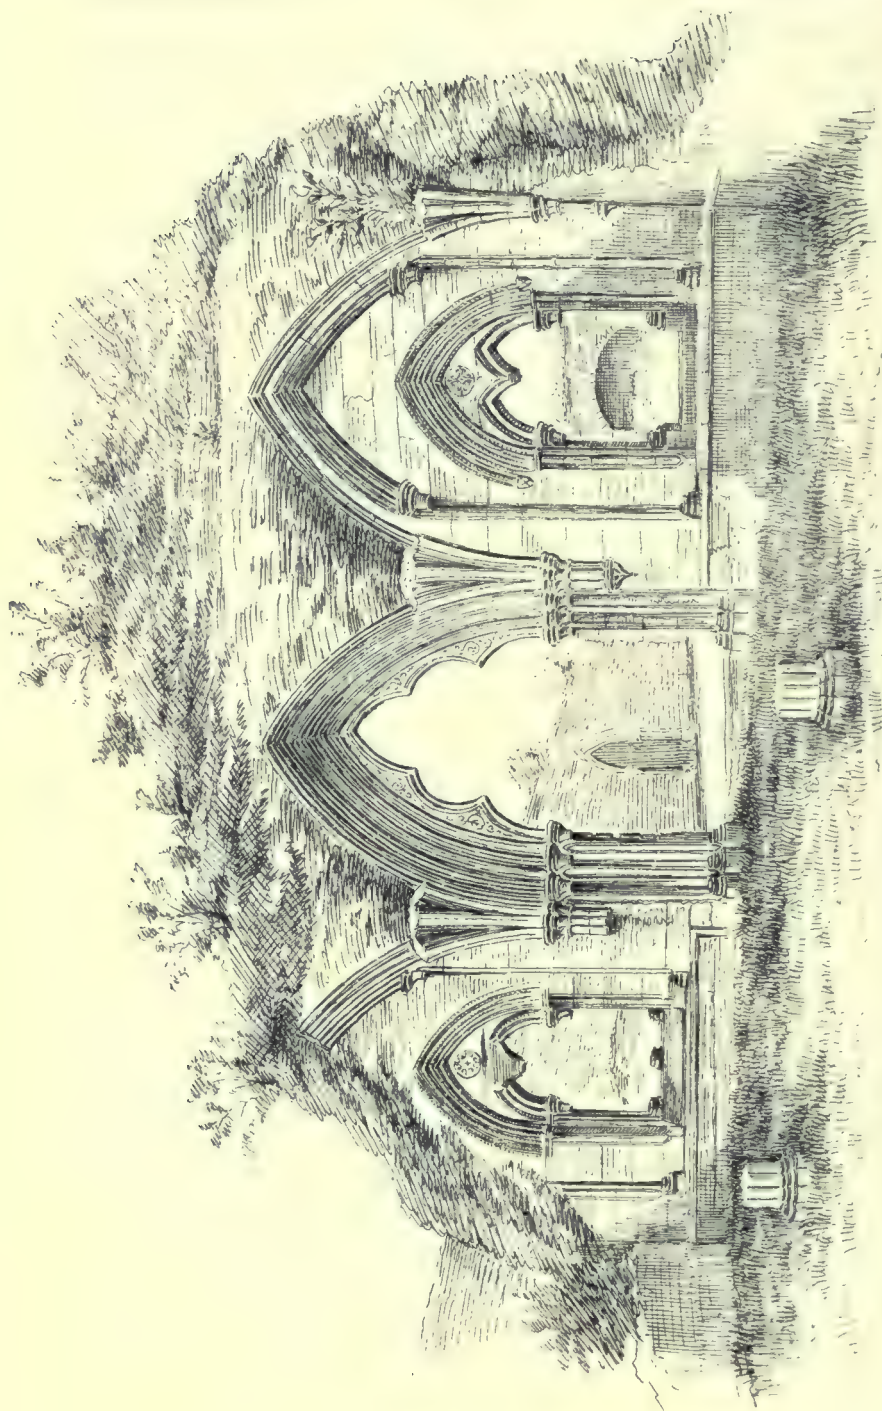
FIG. 361.—Dundrennan Abbey. Interior of West Wall of Chapter House.

Internally the design of this front wall (Fig. 361) corresponds almost exactly with that of the outside, but is, perhaps, even more effective from containing the vaulting shafts and the springing of the broken groins.

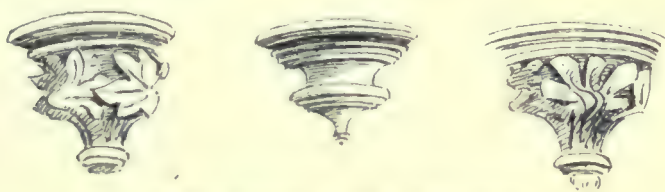
FIG. 362.—Dundrennan Abbey. Caps in Cloisters.

The north and east walls of the cloister still retain the remains of some sharply cut caps, of what has been an arcade, with arches about 3 feet 6 inches apart. The designs have evidently been very varied and full of spirit (Fig. 362), but it is scarcely possible to find one sufficiently well preserved to enable a complete sketch to be made.
